FIELD INSPECTION REPORT

Project Name:	Mountain Valley Pipeline	Inspector:	Marshall Willis
Inspection Date:	Monday, April 13, 2020	Project Contact:	Brian Clauto, Cory Chalmers
Spread I: Franklin County	STA 13996+50 – 14002+00 MVP-FR-306.02	Weather:	Wet

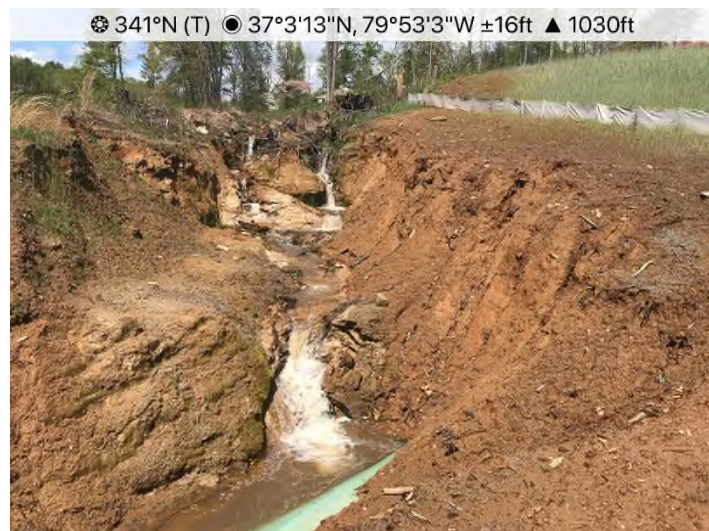
1. Offsite landowner pond discharging via emergency spillway onto MVP ROW. (Figures 1 and 2)
 - Pond discharge treated by MVP controls prior to flowing into stream S-KL36.
 - No impacts to stream S-KL36 were evident.
2. Offsite run-on from upslope LDA deposited sediment within ROW and stream buffer of S-KL36. (Figures 3 and 4)
 - MVP controls treated offsite run-on.
 - Maintenance crews actively repairing damaged controls and stabilizing sediment deposited within the MVP LOD during inspection.

Figure 1: STA 14000+00 – Offsite pond emergency spillway discharging onto MVP LOD.

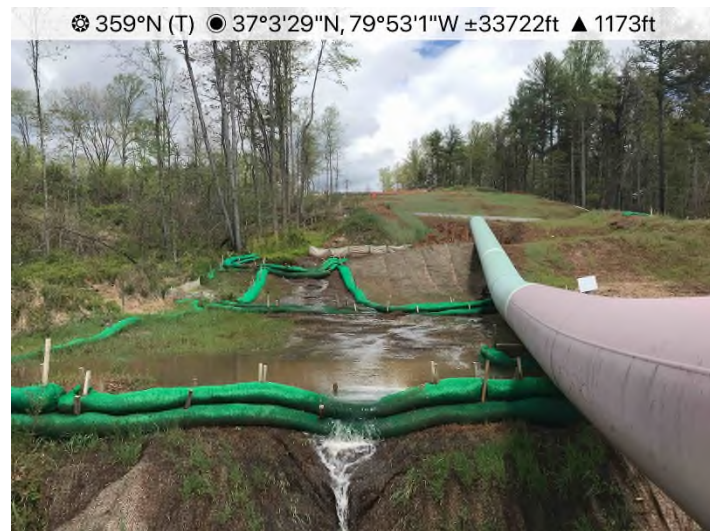
Figure 2: STA 13998+15 – Discharge from offsite pond treated by MVP controls prior to entering stream S-KL36. No impacts observed to Stream S-KL36.

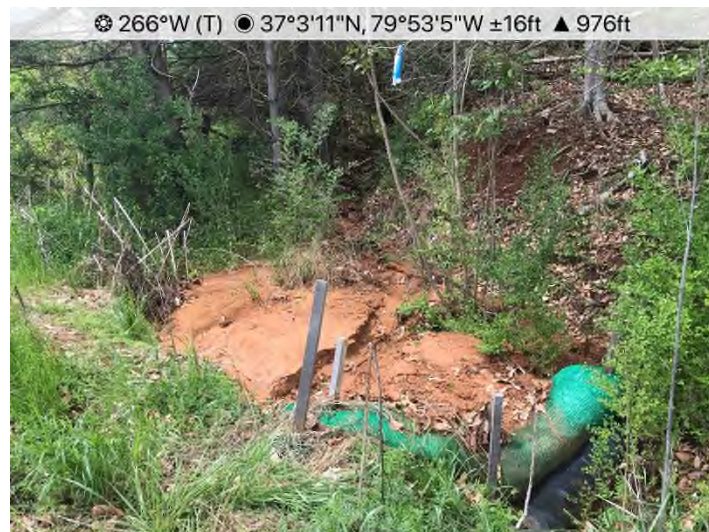
Figure 3: STA 13997+00 – Sediment deposition into MVP controls from offsite run-on along north side of LOD.

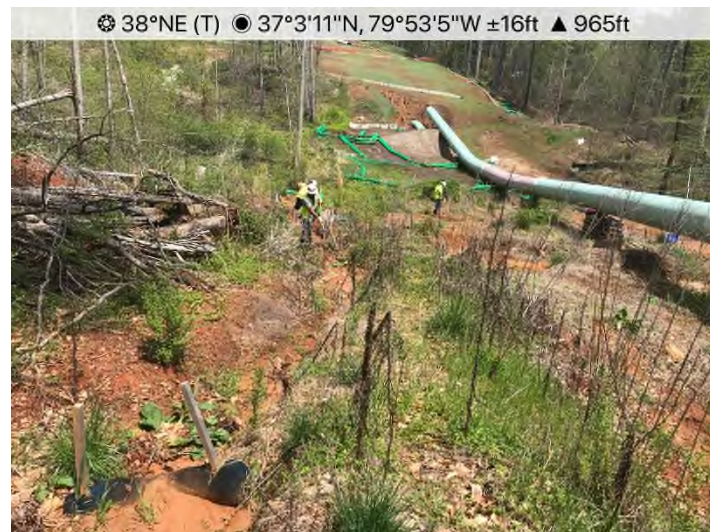
Figure 4: STA 13997+25 – Maintenance crews stabilizing sediment deposited from offsite LDA and repairing controls.
